ABERDEEN AIRPORT

This report describes how your pavement maintenance management program was developed. This program was developed as part of the Network Pavement Management Program project sponsored by the Idaho Transportation Department, Division of Aeronautics. The information and data contained in this report ensures you are in compliance with the requirements of Federal Aviation Administration (FAA) Grant Assurance Number 11 which states that any airport requesting federal funds for pavement improvement projects must have implemented a pavement maintenance management program (PMMP).

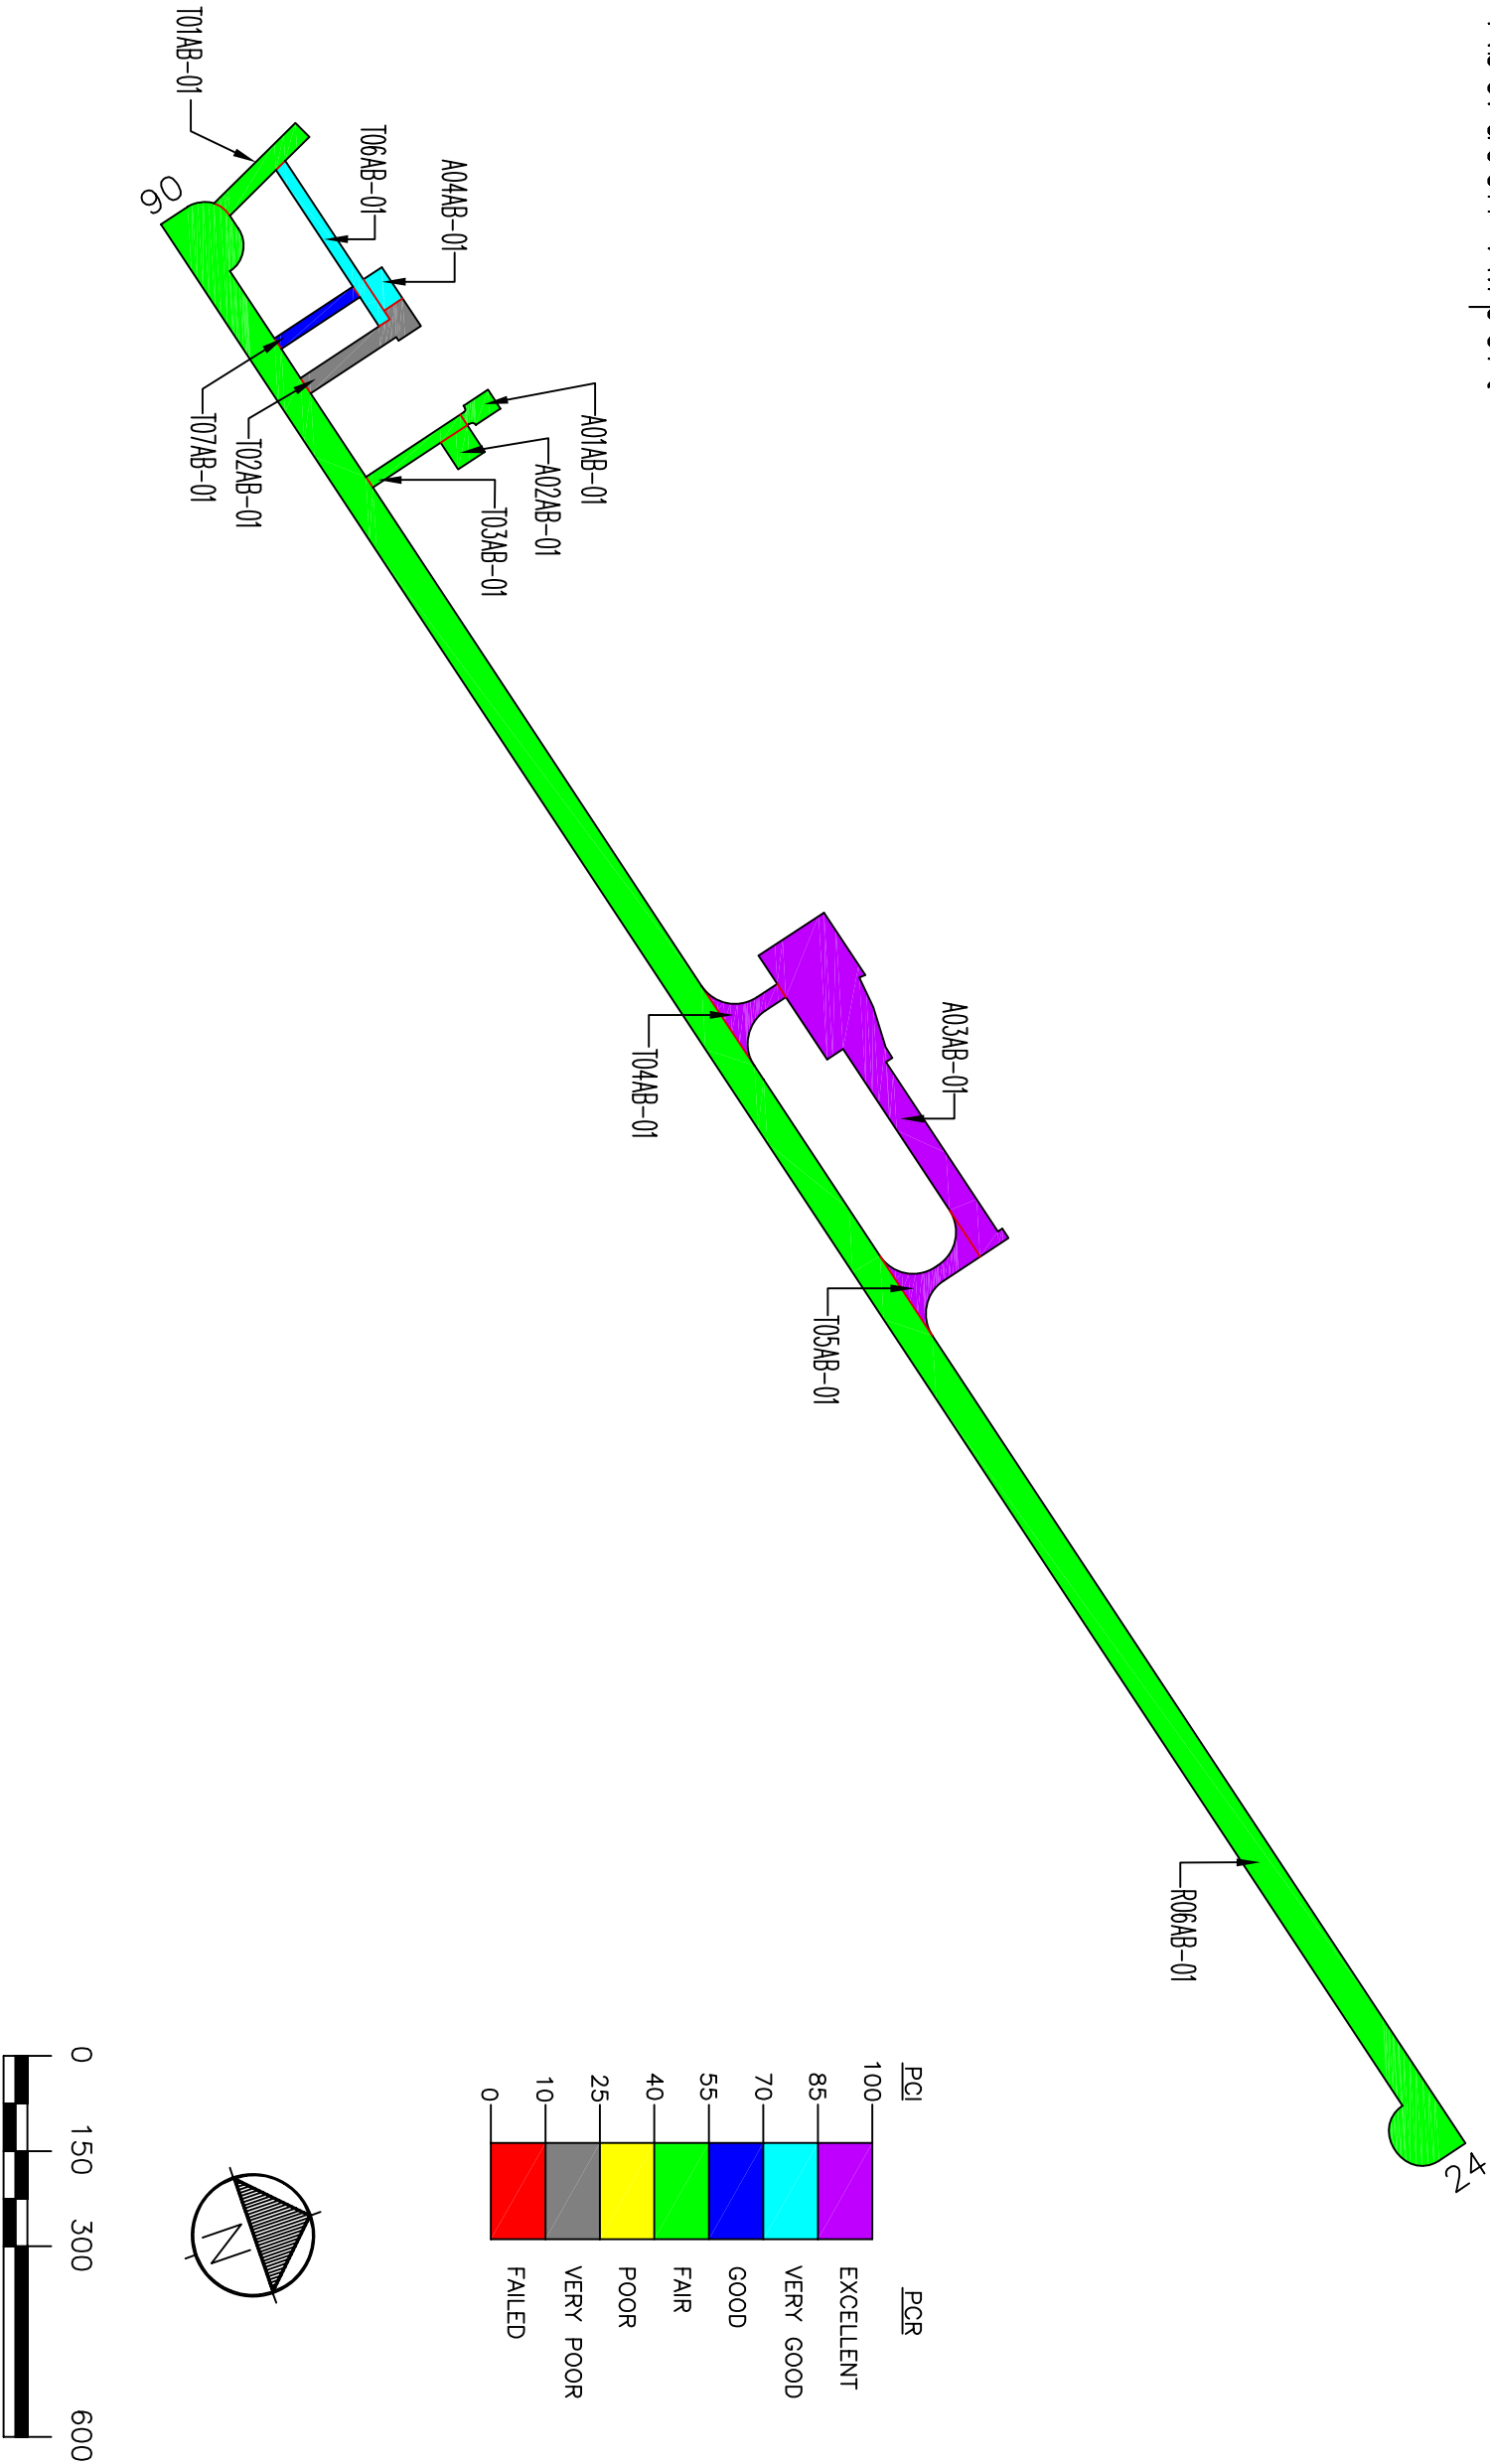
Figure AB-3. Pavement Condition in 2006.
Aberdeen Airport

Using the data collected during the visual inspection, the Micro PAVER software calculated a Pavement Condition Index (PCI) for each pavement section inspected by averaging the PCIs for inspected sample units. Using each section's PCI, a Pavement Condition Rating (PCR) was assigned. The PCIs and associated PCRs from this inspection are shown in Table AB-2. This table also contains projected PCIs for 2011 and 2016 based on pavement deterioration models developed by Micro PAVER using the inspection data from pavements in Idaho having the same surface types. The Branch Condition Report in Appendix 2 summarizes current pavement condition by branch while the Section Condition Report in Appendix 2 lists pavement condition by section. The current PCR is shown graphically in Figure AB-3.

Section PCIs at the airport range from a low of 24 (a PCR of "Very Poor") to a high of 100 (a PCR of "Excellent"). The area-weighted average PCI for all airport pavements is 56, corresponding to an overall PCR of "Good". Figure AB-4 shows how much pavement area is associated with each Pavement Condition Rating category and also shows pavement condition distribution from the inspections conducted in 1996 and 1999. A graphical representation of the projected PCRs presented in Table AB-2 is shown in Figure AB-5.

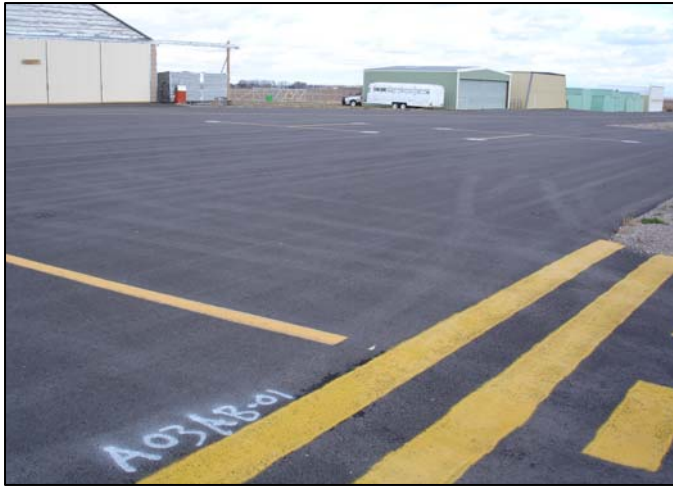
Sample Number: 02 <NO DISTRESSES>	Type: R	Area:	5,000.00SqFt	PCI = 100
Sample Number: 04 <NO DISTRESSES>	Type: R	Area:	5,000.00SqFt	PCI = 100
Sample Number: 06 <NO DISTRESSES>	Type: R	Area:	5,248.00SqFt	PCI = 100
Sample Number: 08 <NO DISTRESSES>	Type: R	Area:	4,500.00SqFt	PCI = 100

Section: A03AB-01
No Distress

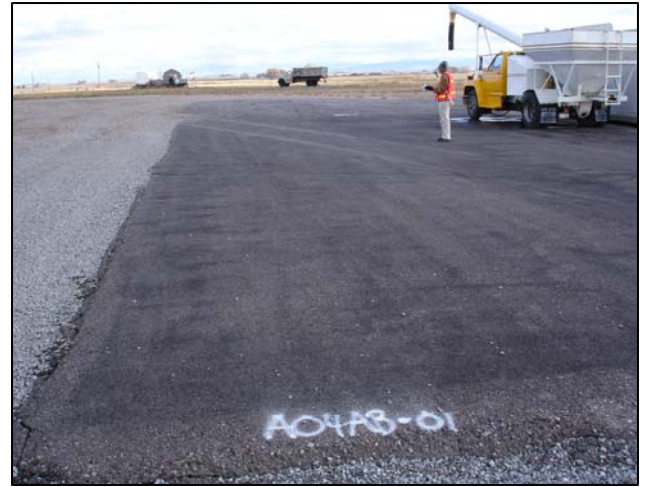
Sample Number:	01	Type:	R	Area:	2,065.00SqFt	PCI = 82
48	LONGITUDINAL/TRANSVERSE	CRACKING	M	54.01	Ft

Section: A04AB-01
Longitudinal & Transverse Cracking

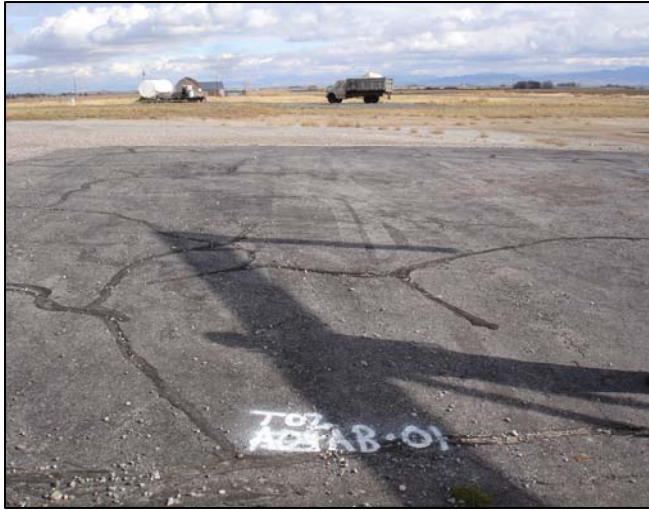
Sample Number:	1	Type:	R	Area:	6,741.00SqFt	PCI =	24
41	ALLIGATOR CRACKING	L		972.99	SqFt		
43	BLOCK CRACKING	M		5,518.95	SqFt		
45	DEPRESSION	L		60.00	SqFt		
53	RUTTING	L		156.00	SqFt		
52	WEATHERING/RAVELING	L		150.00	SqFt

Section: T02AB-01
Block Cracking, Alligator Cracking

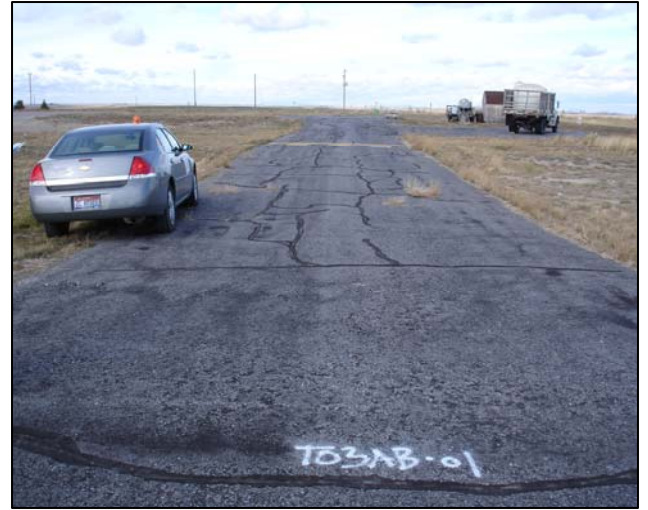
Sample Number:	1	Type:	R	Area:	3,560.00SqFt	PCI = 42
43	BLOCK CRACKING			M	3,559.97 SqFt	
53	RUTTING			L	100.00 SqFt

Section: T03AB-01
Block Cracking

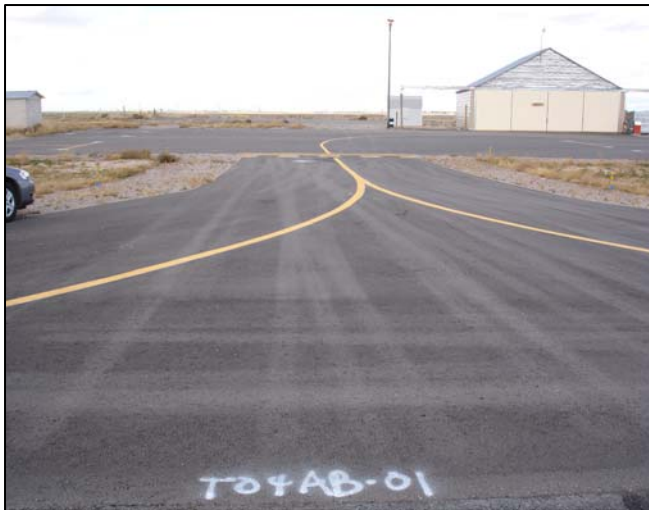
Sample Number: 1 Type: R Area: 4,202.00SqFt PCI = 90
45 DEPRESSION L 16.00 SqFt
48 LONGITUDINAL/TRANSVERSE CRACKING L 85.02 Ft

Section: T04AB
No Distress

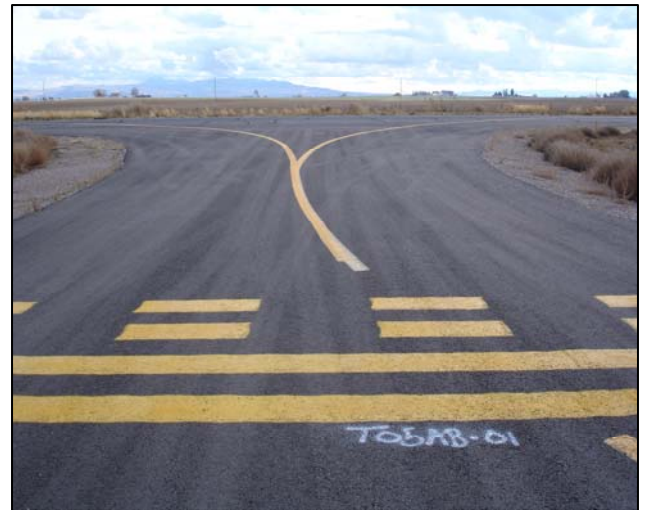
<NO DISTRESSES>

Section: T05AB-01
No Distress

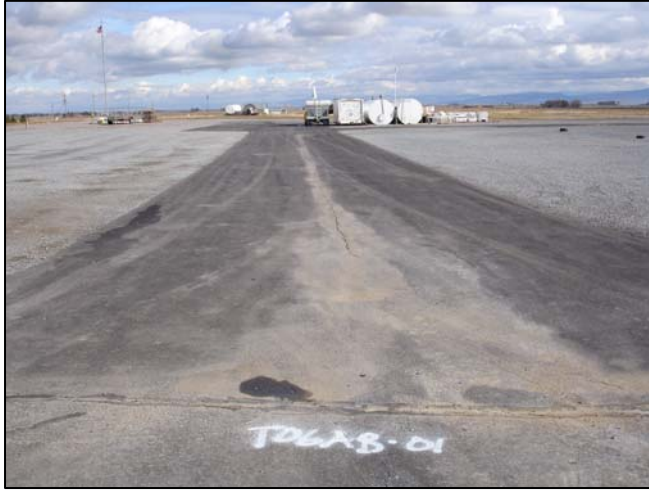
Sample Number:	1	Type:	R	Area:	5,930.00SqFt	PCI = 73
45	DEPRESSION			L	25.00 SqFt	
48	LONGITUDINAL/TRANSVERSE CRACKING			L	77.02 Ft	
48	LONGITUDINAL/TRANSVERSE CRACKING			M	181.05 Ft

Section: T06AB-01
Longitudinal & Transverse Cracking

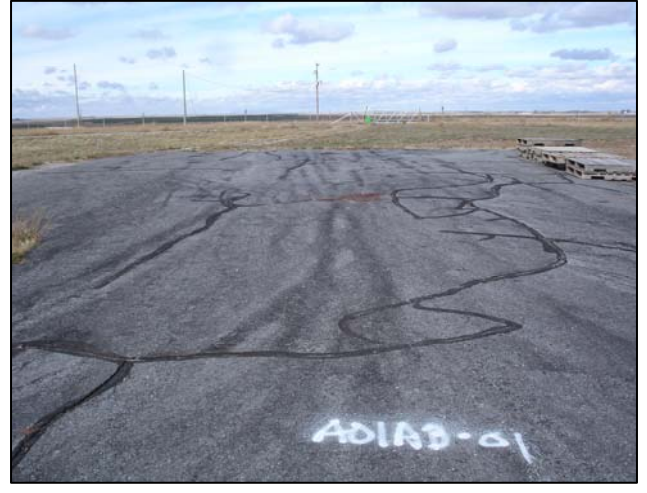
Sample Number:	01	Type:	R	Area:	1,992.00SqFt	PCI = 42
43	BLOCK CRACKING			M	1,991.98 SqFt	
52	WEATHERING/RAVELING			L	199.00 SqFt

Section: A01AB-01
Block Cracking

Network	Branch	Section	Distress	Severity	Distress Quantity	Units	Action	Maint. Quantity	Units	Unit Cost	Total Cost
ABERDEEN	A01AB	1	BLOCK CR	M	1,992.00	SQFT	Crack Sealing - AC	607.2	Ft	\$1.50	\$910.74
ABERDEEN	A01AB	1	WEATH/RAVEL	L	199	SQFT	No Localized M & R	199	SqFt	\$0.00	\$0.00
Total											\$910.74
ABERDEEN	A02AB	1	BLOCK CR	M	2,500.00	SQFT	Crack Sealing - AC	762	Ft	\$1.50	\$1,143.00
ABERDEEN	A02AB	1	WEATH/RAVEL	L	250	SQFT	No Localized M & R	250	SqFt	\$0.00	\$0.00
Total											\$1,143.00
ABERDEEN	A04AB	1	L & T CR	M	55	FT	Crack Sealing - AC	54	Ft	\$1.50	\$81.02
Total											\$81.02
ABERDEEN	R06AB	1	BLOCK CR	L	23,145.00	SQFT	No Localized M & R	23,144.90	SqFt	\$0.00	\$0.00
ABERDEEN	R06AB	1	BLOCK CR	M	154,683.00	SQFT	Crack Sealing - AC	47,147.10	Ft	\$1.50	\$70,721.20
ABERDEEN	R06AB	1	WEATH/RAVEL	L	8,981.00	SQFT	No Localized M & R	8,980.20	SqFt	\$0.00	\$0.00
Total											\$70,721.20
ABERDEEN	T01AB	1	BLEEDING	N	192	SQFT	No Localized M & R	192	SqFt	\$0.00	\$0.00

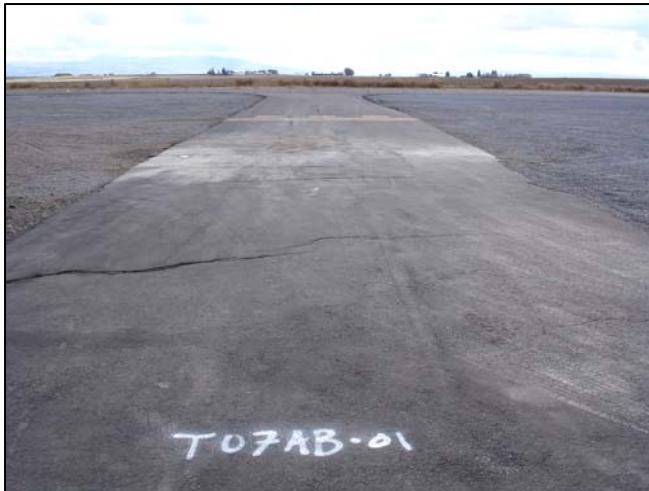
Sample Number:	1	Type:	R	Area:	2,960.00SqFt	PCI = 63
48	LONGITUDINAL/TRANSVERSE	CRACKING	L		55.01 Ft	
48	LONGITUDINAL/TRANSVERSE	CRACKING	M		222.06 Ft

Section: T07AB-01
Longitudinal & Transverse Cracking

NOTE: Section T07AB-01 needs to be Overlaid
in 2010.

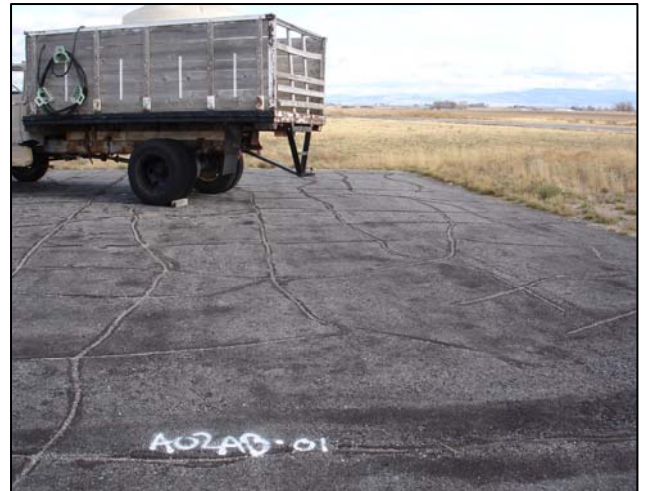
Sample Number:	01	Type:	R	Area:	2,500.00SqFt	PCI = 42
43	BLOCK CRACKING			M	2,499.98 SqFt	
52	WEATHERING/RAVELING			L	250.00 SqFt

Section: A02AB-01
Block Cracking
